KEEPING ASSEMBLY VENUE EGRESS PATHS USABLE

By Ron Coté, P.E., Principal Life Safety Engineer

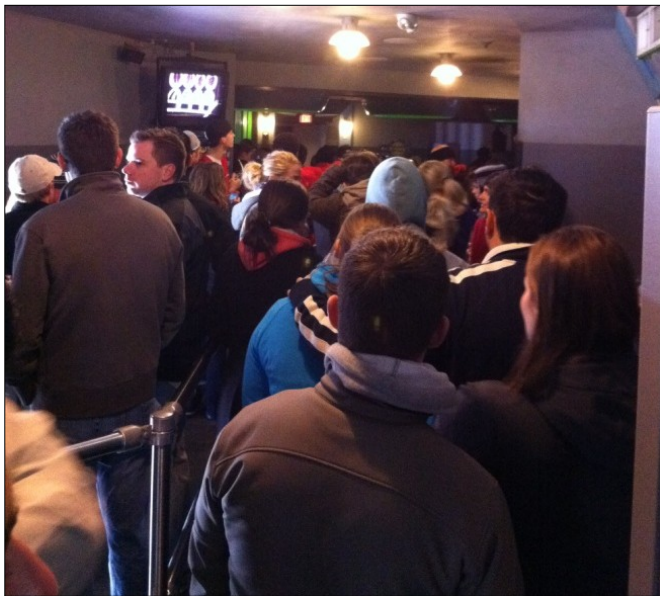
Exhibit 1. *Assembly venue crowd packing.*

Large assembly venues are characterized by crowd packing where patrons often are not familiar with egress paths other than the main entrance/exit through which they entered the facility. Exhibit 1 depicts the level of crowd packing common in assembly venues. Compliance with applicable building, fire and life safety codes at time of construction provides facility operators - upon initial occupancy - with the features and systems needed to protect patrons' lives from fire and similar emergency. These systems and features must be kept in working order. Changes, as might be made to accommodate function after the facility is up-and-running, need to be evaluated relative to their potential to adversely impact the existing life safety systems.

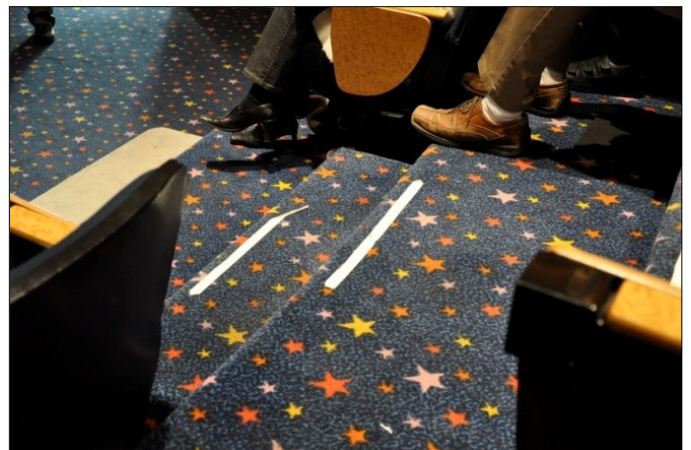
Exhibit 2. *Stepped aisle nosing marking attempted with nonpermanent tape. (Photo courtesy of Jake Pauls)*

Patrons traverse the multiple seating elevations via stepped aisles which create potential for trips and falls. The model codes, like NFPA 101® - *Life Safety Code*®, where used to construct the facility, provide a safe and usable stepped aisle, complete with handrails to help arrest a fall in its initial stage. But, the aisle floor coverings and the cues to safe aisle use, such as cautionary marking striping at the leading edge of each tread, must be maintained. Exhibit 2 depicts tread nosing marking attempted with the use of tape that is set back from the nosing or leading edge of the tread. Note that the tape is not permanent and has peeled back from the tread. Had the tape been positioned at the nosing or leading edge of the tread, it would have been subject to greater wear by users and would have failed earlier. Exhibit 3 shows nosing marking accomplished by the contrasting floor covering used at the leading edge of the tread. Its presence and effectiveness is expected to last for years.

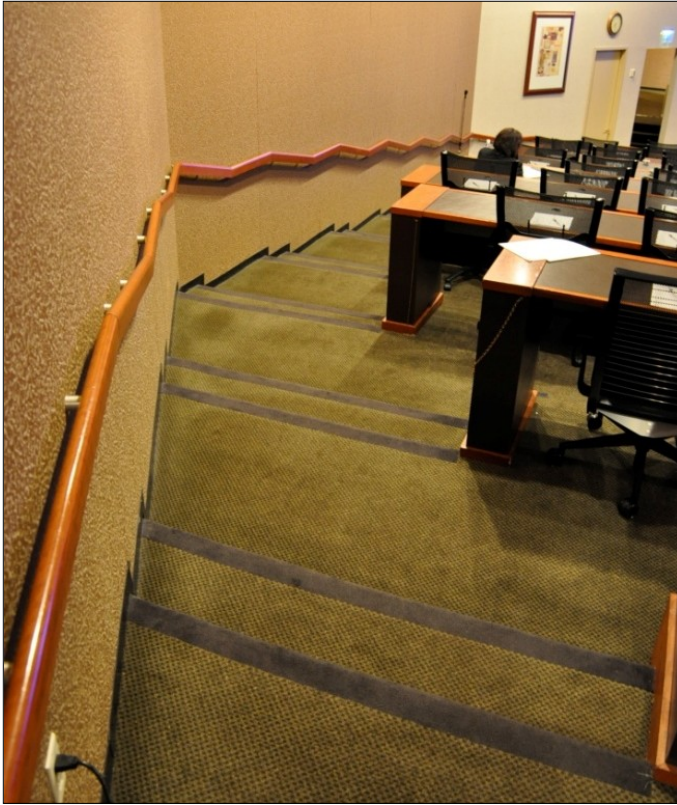
Exhibit 3. *Stepped aisle nosing marking accomplished with permanent flooring material. (Photo courtesy of Jake Pauls)*

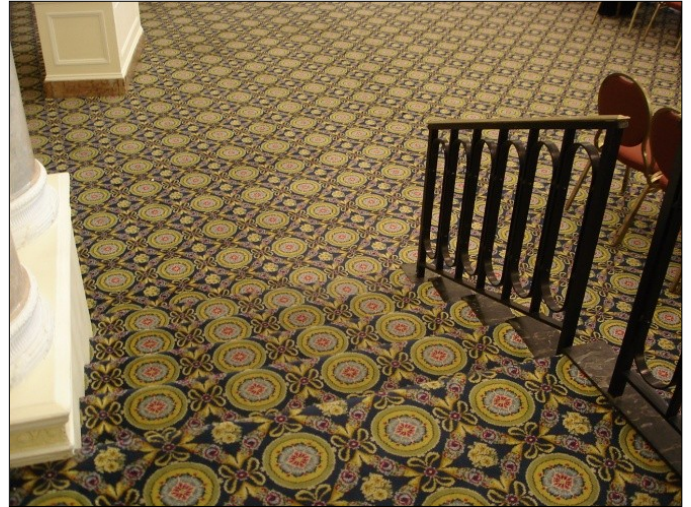
Exhibit 4. *Patterned carpet obscures any indication of tread edge location. (Photo courtesy of Jake Pauls)*

Small elevation differences, as might be created by a couple of risers, create an additional tripping hazard as the presence and of the treads is not as obvious, to the approaching occupant, as that presented by a full flight of stairs. In Exhibit 4, the small elevation difference is mitigated, as required by NFPA 101, by stair treads with an exaggerated depth, complete with a handrail at one side, but the patterned carpet obscures any indication of tread edge location - the stairs are not seen as separate stepping surfaces.

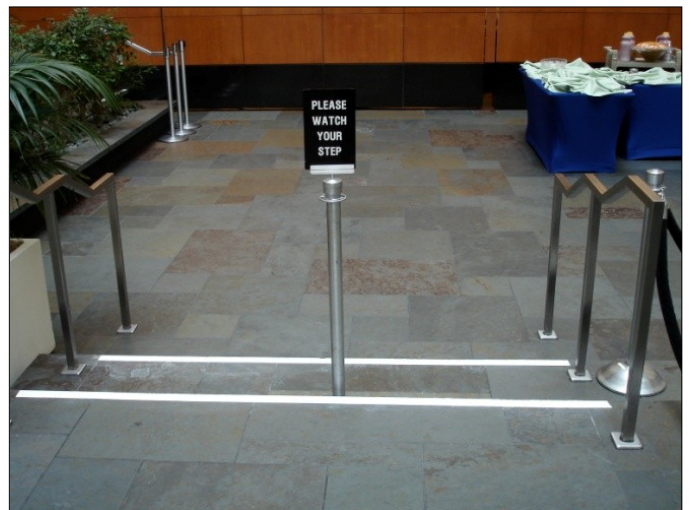
Exhibit 5. *Small elevation change effectively marked with striping tape and caution sign. (Photo courtesy of Jake Pauls)*

Exhibit 5 depicts a small elevation, similar to that shown in Exhibit 4. The stair treads have the requisite exaggerated depth; the presence and location of each step is marked with contrasting tape; handrails are provided at both sides of the stair; and a placard stating “please watch your step” is provided as an extra precaution.

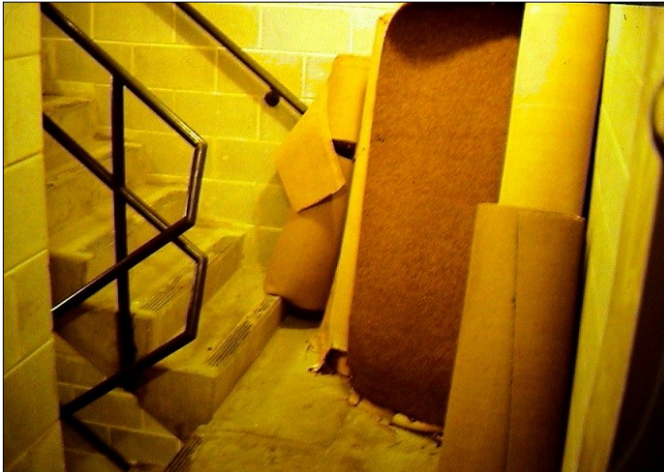
Exhibit 6. *Rolled carpet stored in an exit enclosure.*
(Photo courtesy of Jake Pauls)

ferred to in NFPA 101 as the main entrance/exit. Yet other exits are required. They take the form of doors and exit stair enclosures that are not used on a regular basis. The exit enclosure needs to be inspected as it is an inviting place to store things. Exhibit 6 depicts rolled carpet stored within an exit stair enclosure. The storage encroaches on the required egress path and introduces combustibles that could burn so as to prevent the use of the stair enclosure as an egress route.

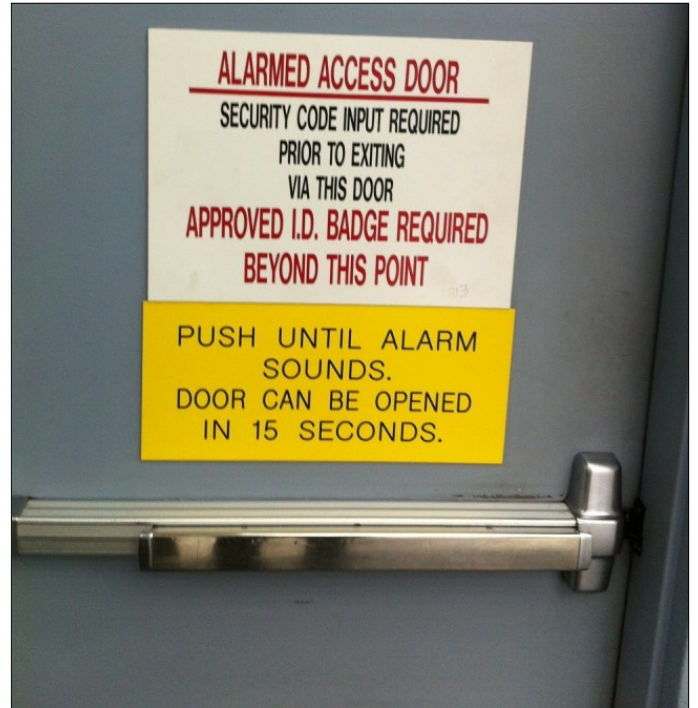
Exhibit 7. *Door with delayed egress hardware and conflicting information placards.*

A well-designed egress system can be compromised by a lack of visual cues or inconsistent/incorrect user information. NFPA 101 requires exit signs, directional exit signs, and NO Exit signs to provide occupants with sufficient information to make effective use of egress routes with which the occupants might have no familiarity. The problem of conflicting or incorrect information can be worse than providing no information. Exhibit 7 depicts signage on a door equipped with delayed egress locking hardware. The sign directing the user to “Push Until Alarm Sounds...” is required by NFPA 101. The sign advising that a security code must be inputted prior to exiting via the door might be correct for non-emergency, day-to-day use by authorized personnel but is incorrect relative to the operation of the door under fire or similar emergency. The conflicting information might cause a person to leave the area in search of another exit door rather than attempting to open this door.
